**RCRA SITE SCREENING INSPECTION REPORT**  
**Enforcement Confidential – Deliberative Process**

SITE NAME: Canton Drop Forge  
EPA ID NUMBER: OHD004465142  
ADDRESS: 4575 Southway Street S.W.  
Canton, Ohio 44706  
DATE OF INSPECTION: July 1, 2011  
EPA INSPECTOR: Michael Beedle

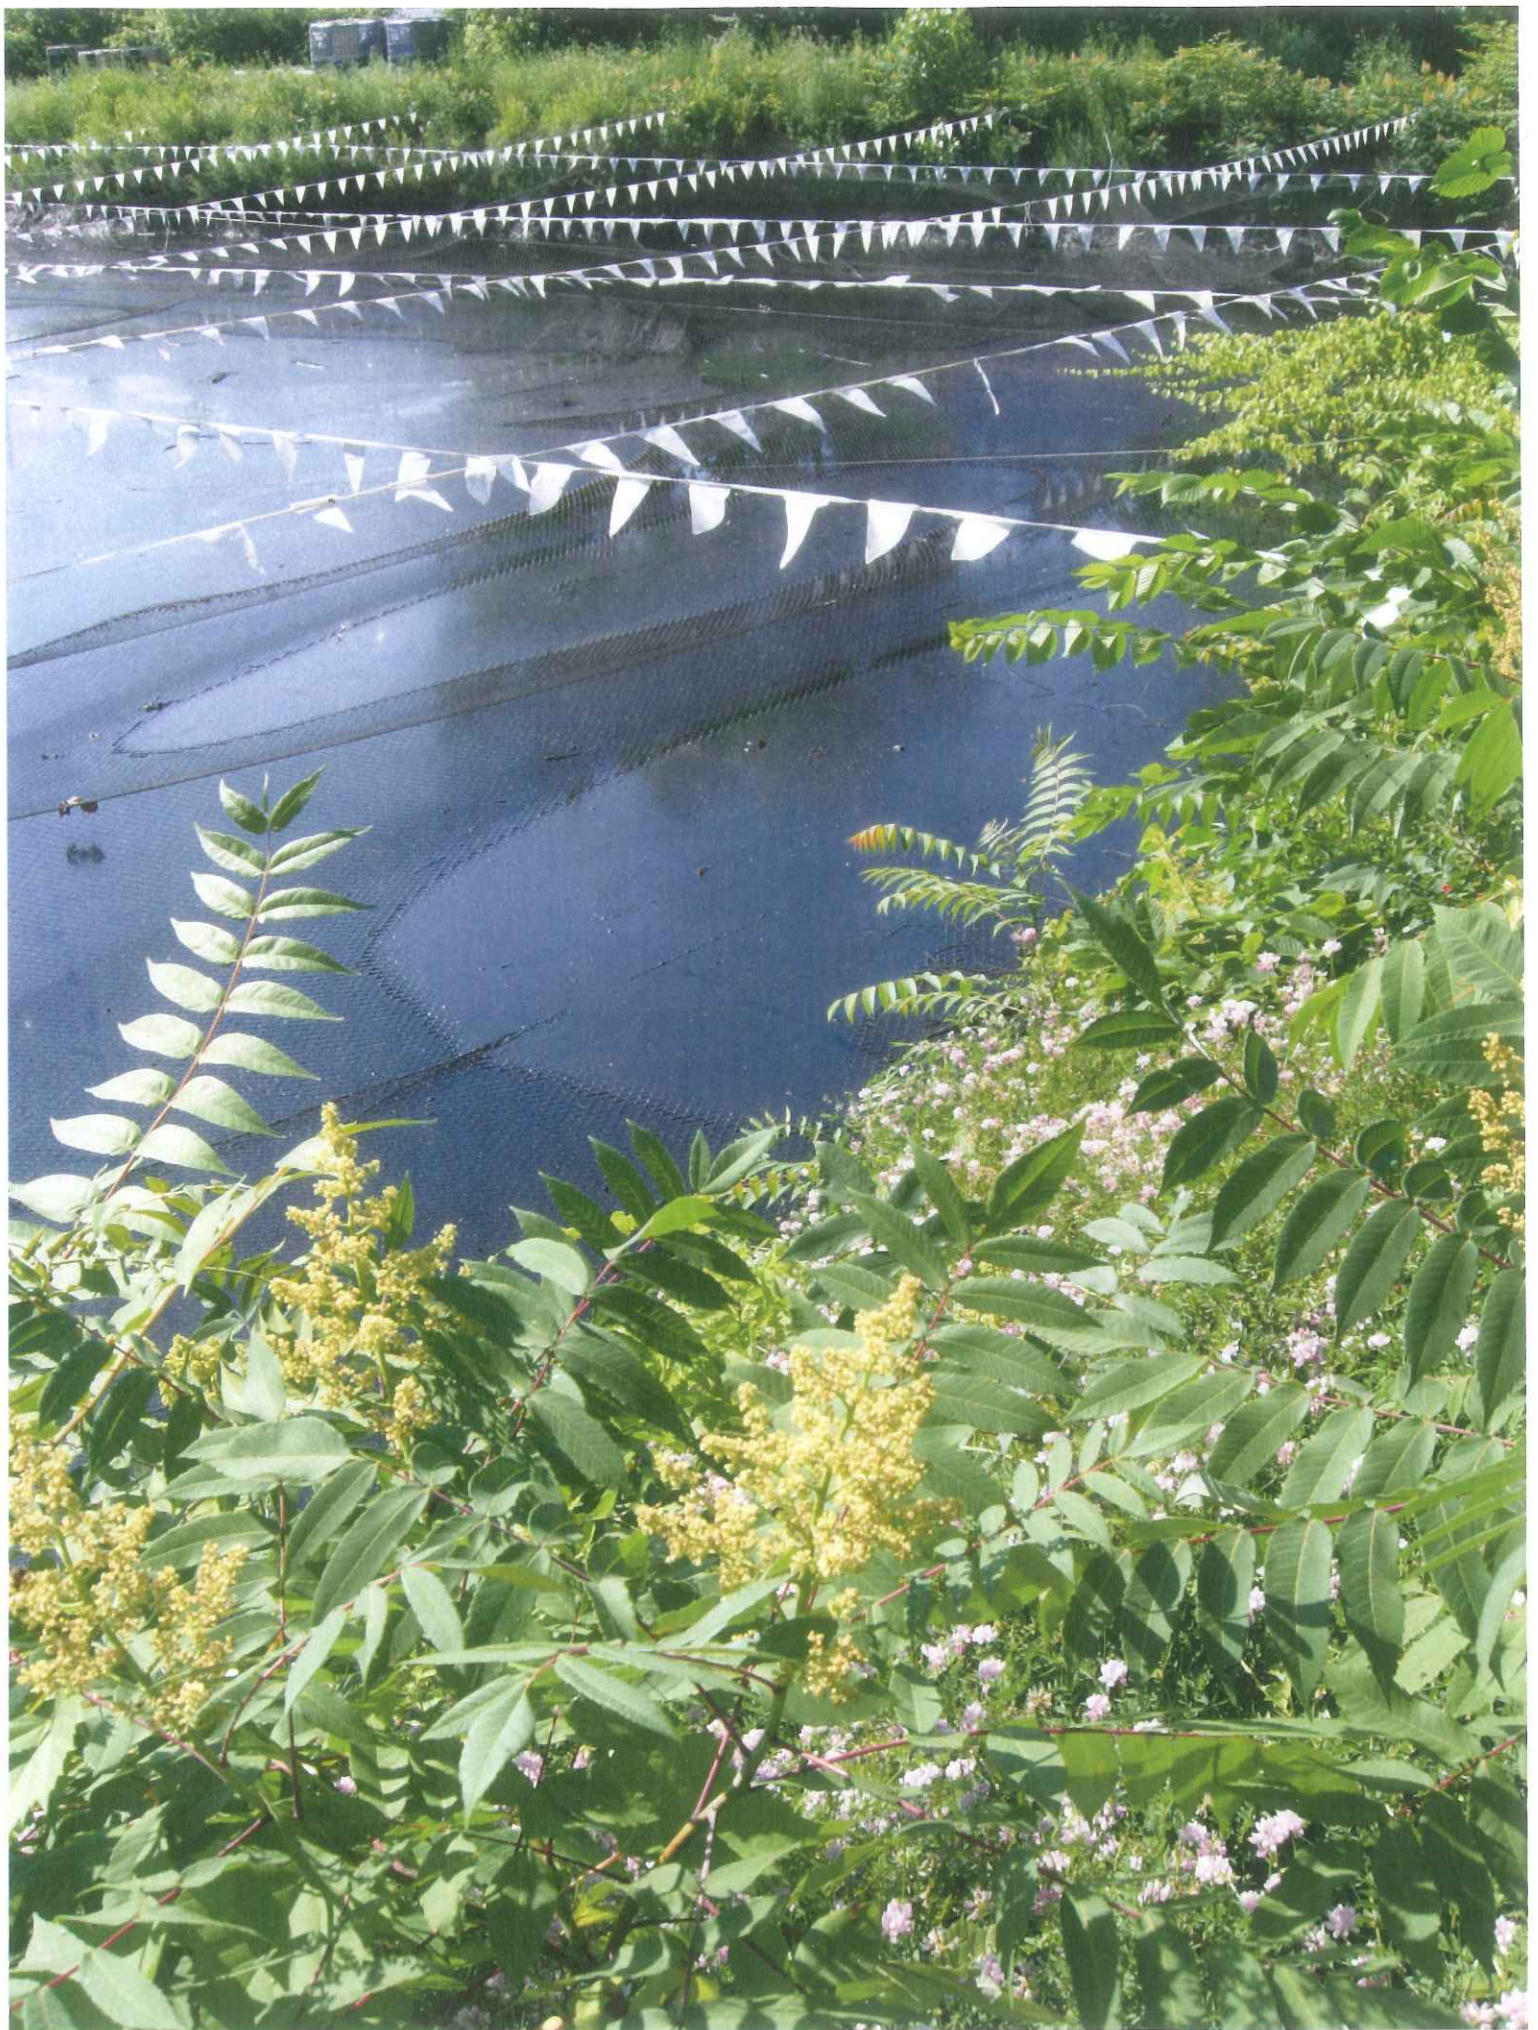
Canton Drop Forge Photo 08, by Mike Beedle ,2011/07/01 07:38:09

| Photo | Description |
|---|--|
| 8 | Pond 2. Facing southeast. Netting can be seen in the oil. Pond netted and flagged. |

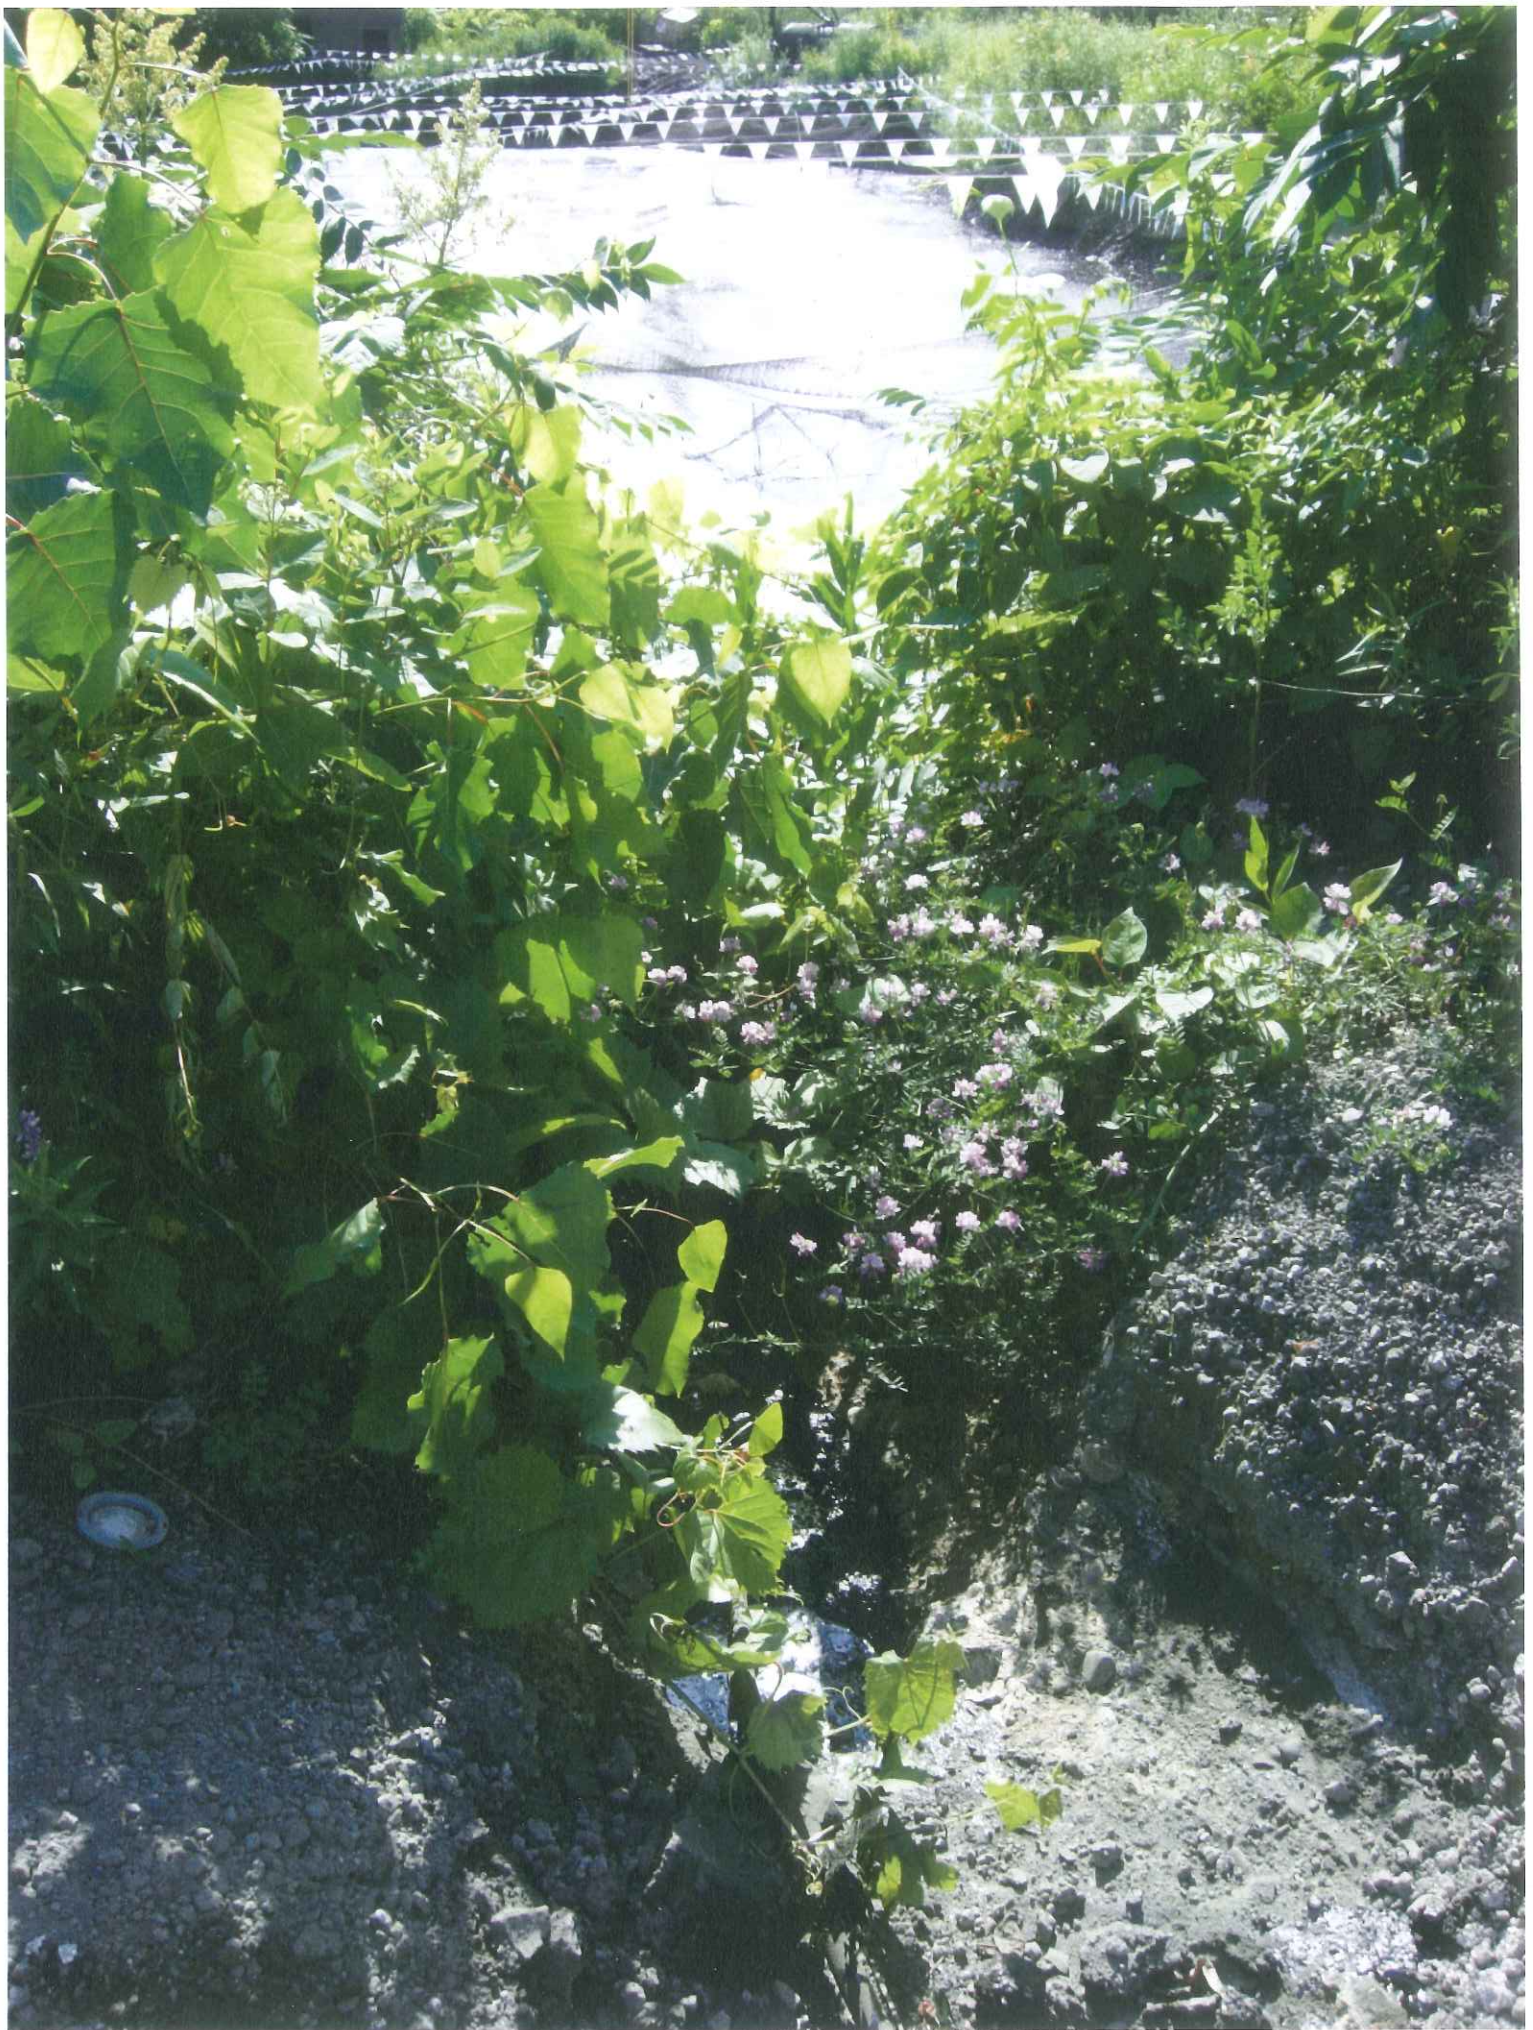
Canton Drop Forge Photo 09, by Mike Beedle ,2011/07/01 07:39:06

Photographs 7-10 were taken from the west bank of Pond 2 facing east. Photographs 9 and 10 are of trench and hose coming out of Pond 2. The trench had oil in it and was oil stained. As we walked the southern perimeter of the pond, I noticed three 275-gallon totes containing oil (photographs 11-12) and ten 55-gallon red drums staged (photograph 13). At least one of the 55-gallon drums was marked "used". I explained there is a regulatory requirement to label or mark used oil containers "Used Oil".

| Photo | Description |
|---|--|
| 9 | Trench on west (southwest) side of Pond 2. A hose runs out of this trench and there was oil and oil staining in the trench. See photograph 10 of the hose. |

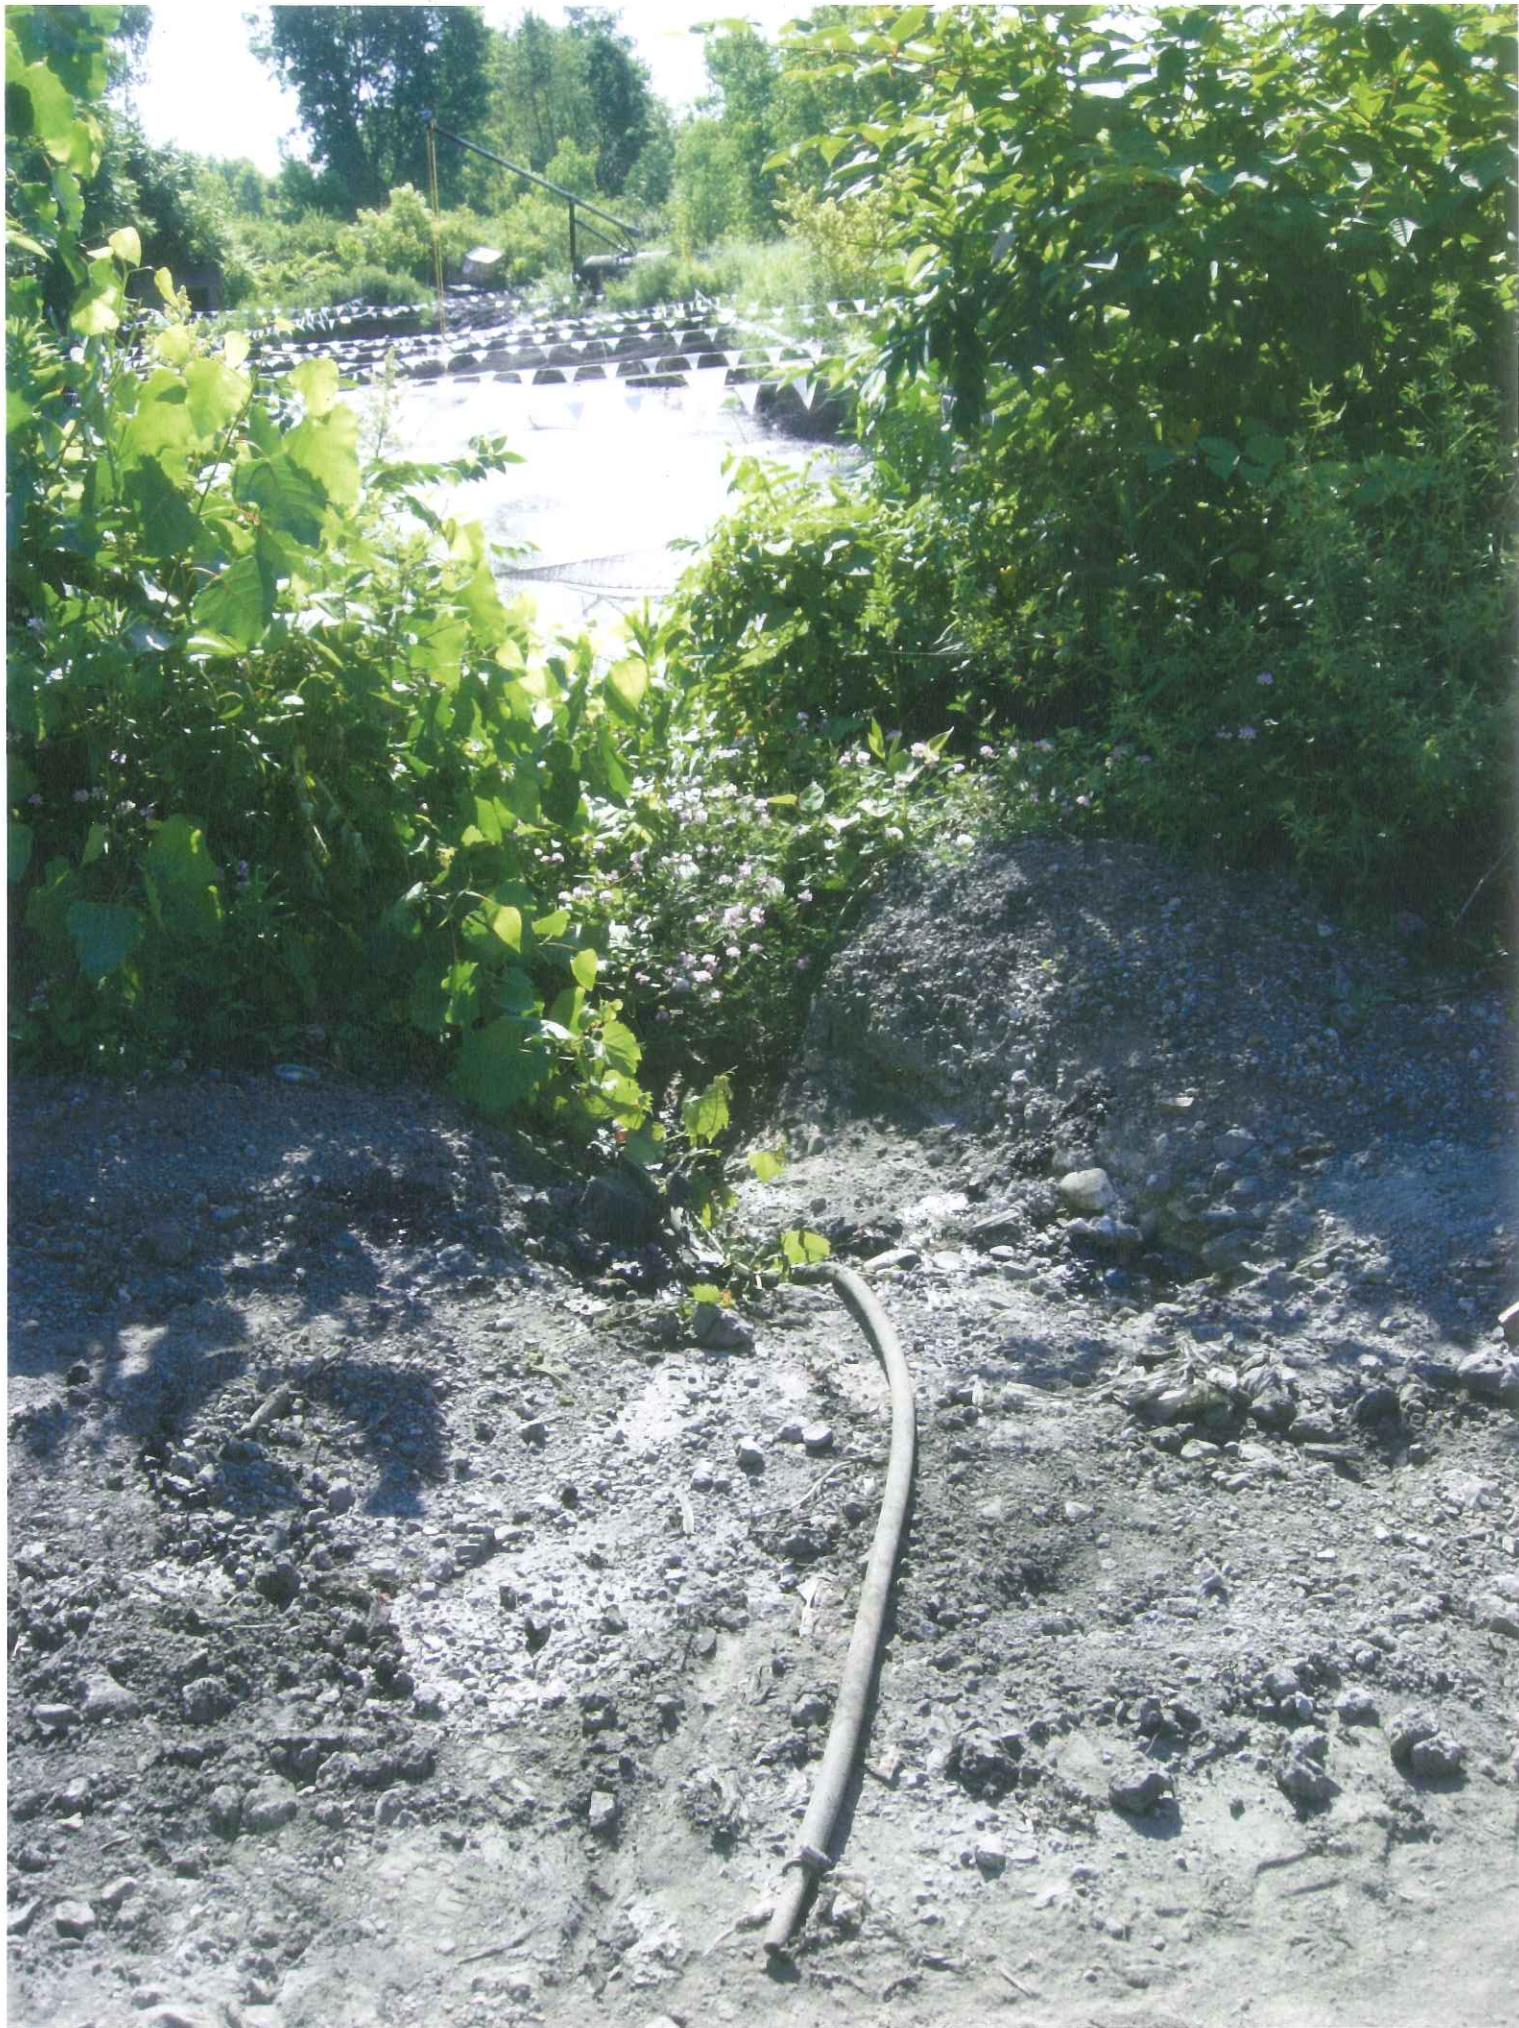
Canton Drop Forge Photo 10, by Mike Beedle ,2011/07/01 07:39:13

| Photo | Description |
|---|--|
| 10 | Hose coming out of Pond 2 on west (southwest) side. |

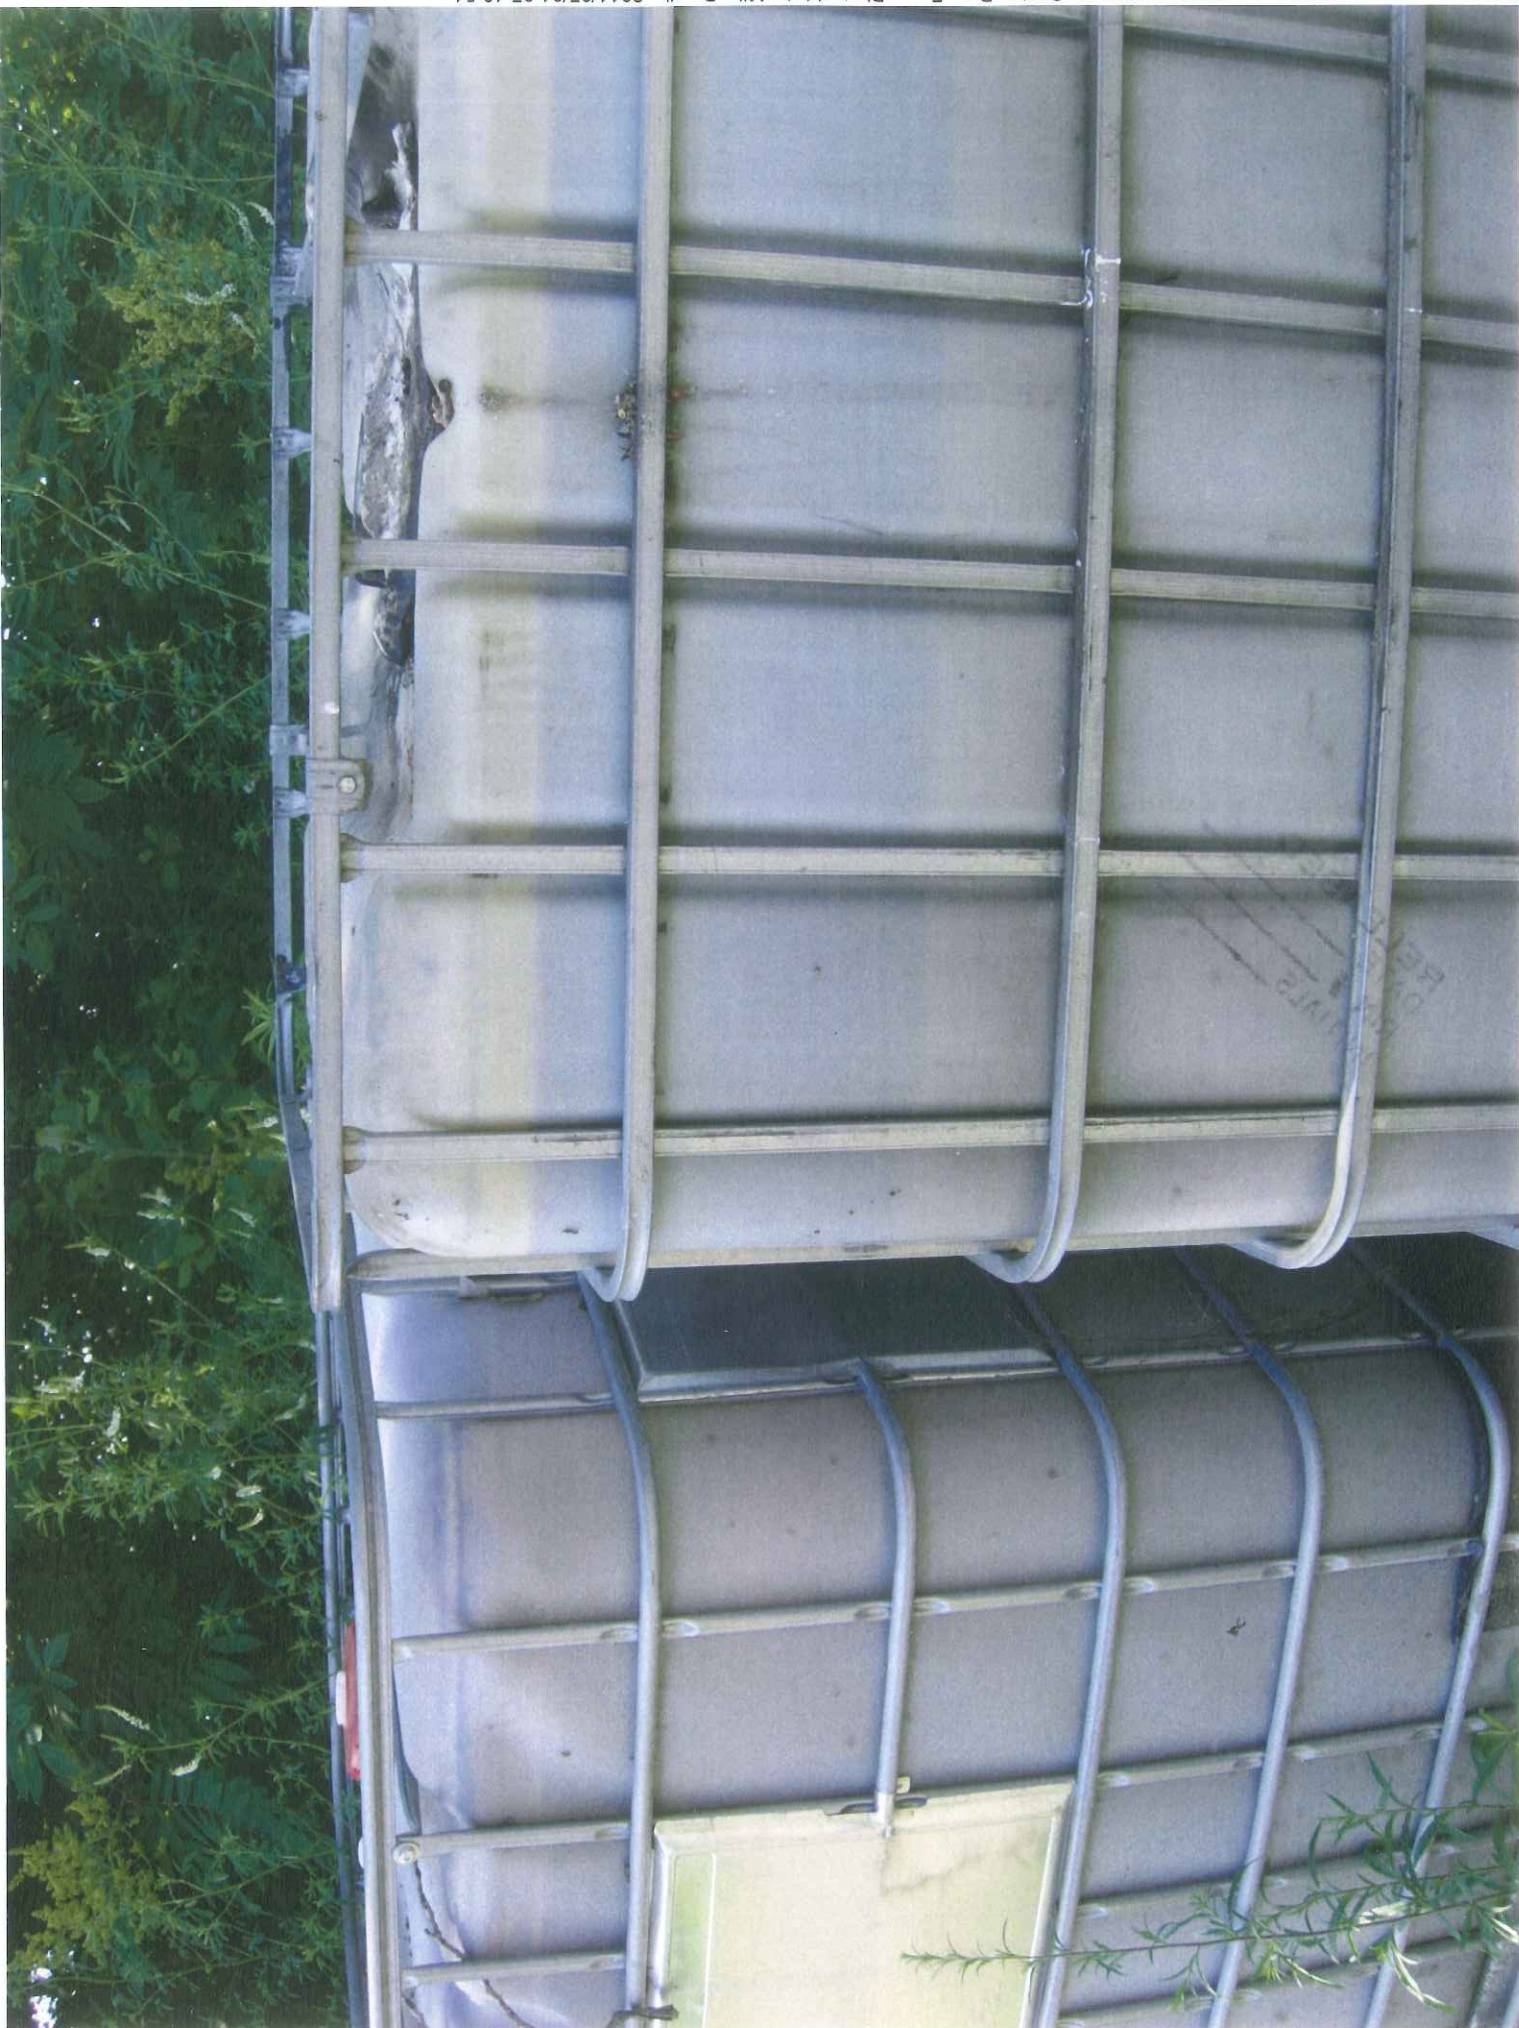
Canton Drop Forge Photo 11, by Mike Beedle, 2011/07/01 07:40:54

| Photo | Description |
|---|--|
| 11 | Two Totes. South side of Pond 2. Totes are ~ 275-gallon and were mostly full. Three full totes in the area, see Photograph 12 for the third tote. |

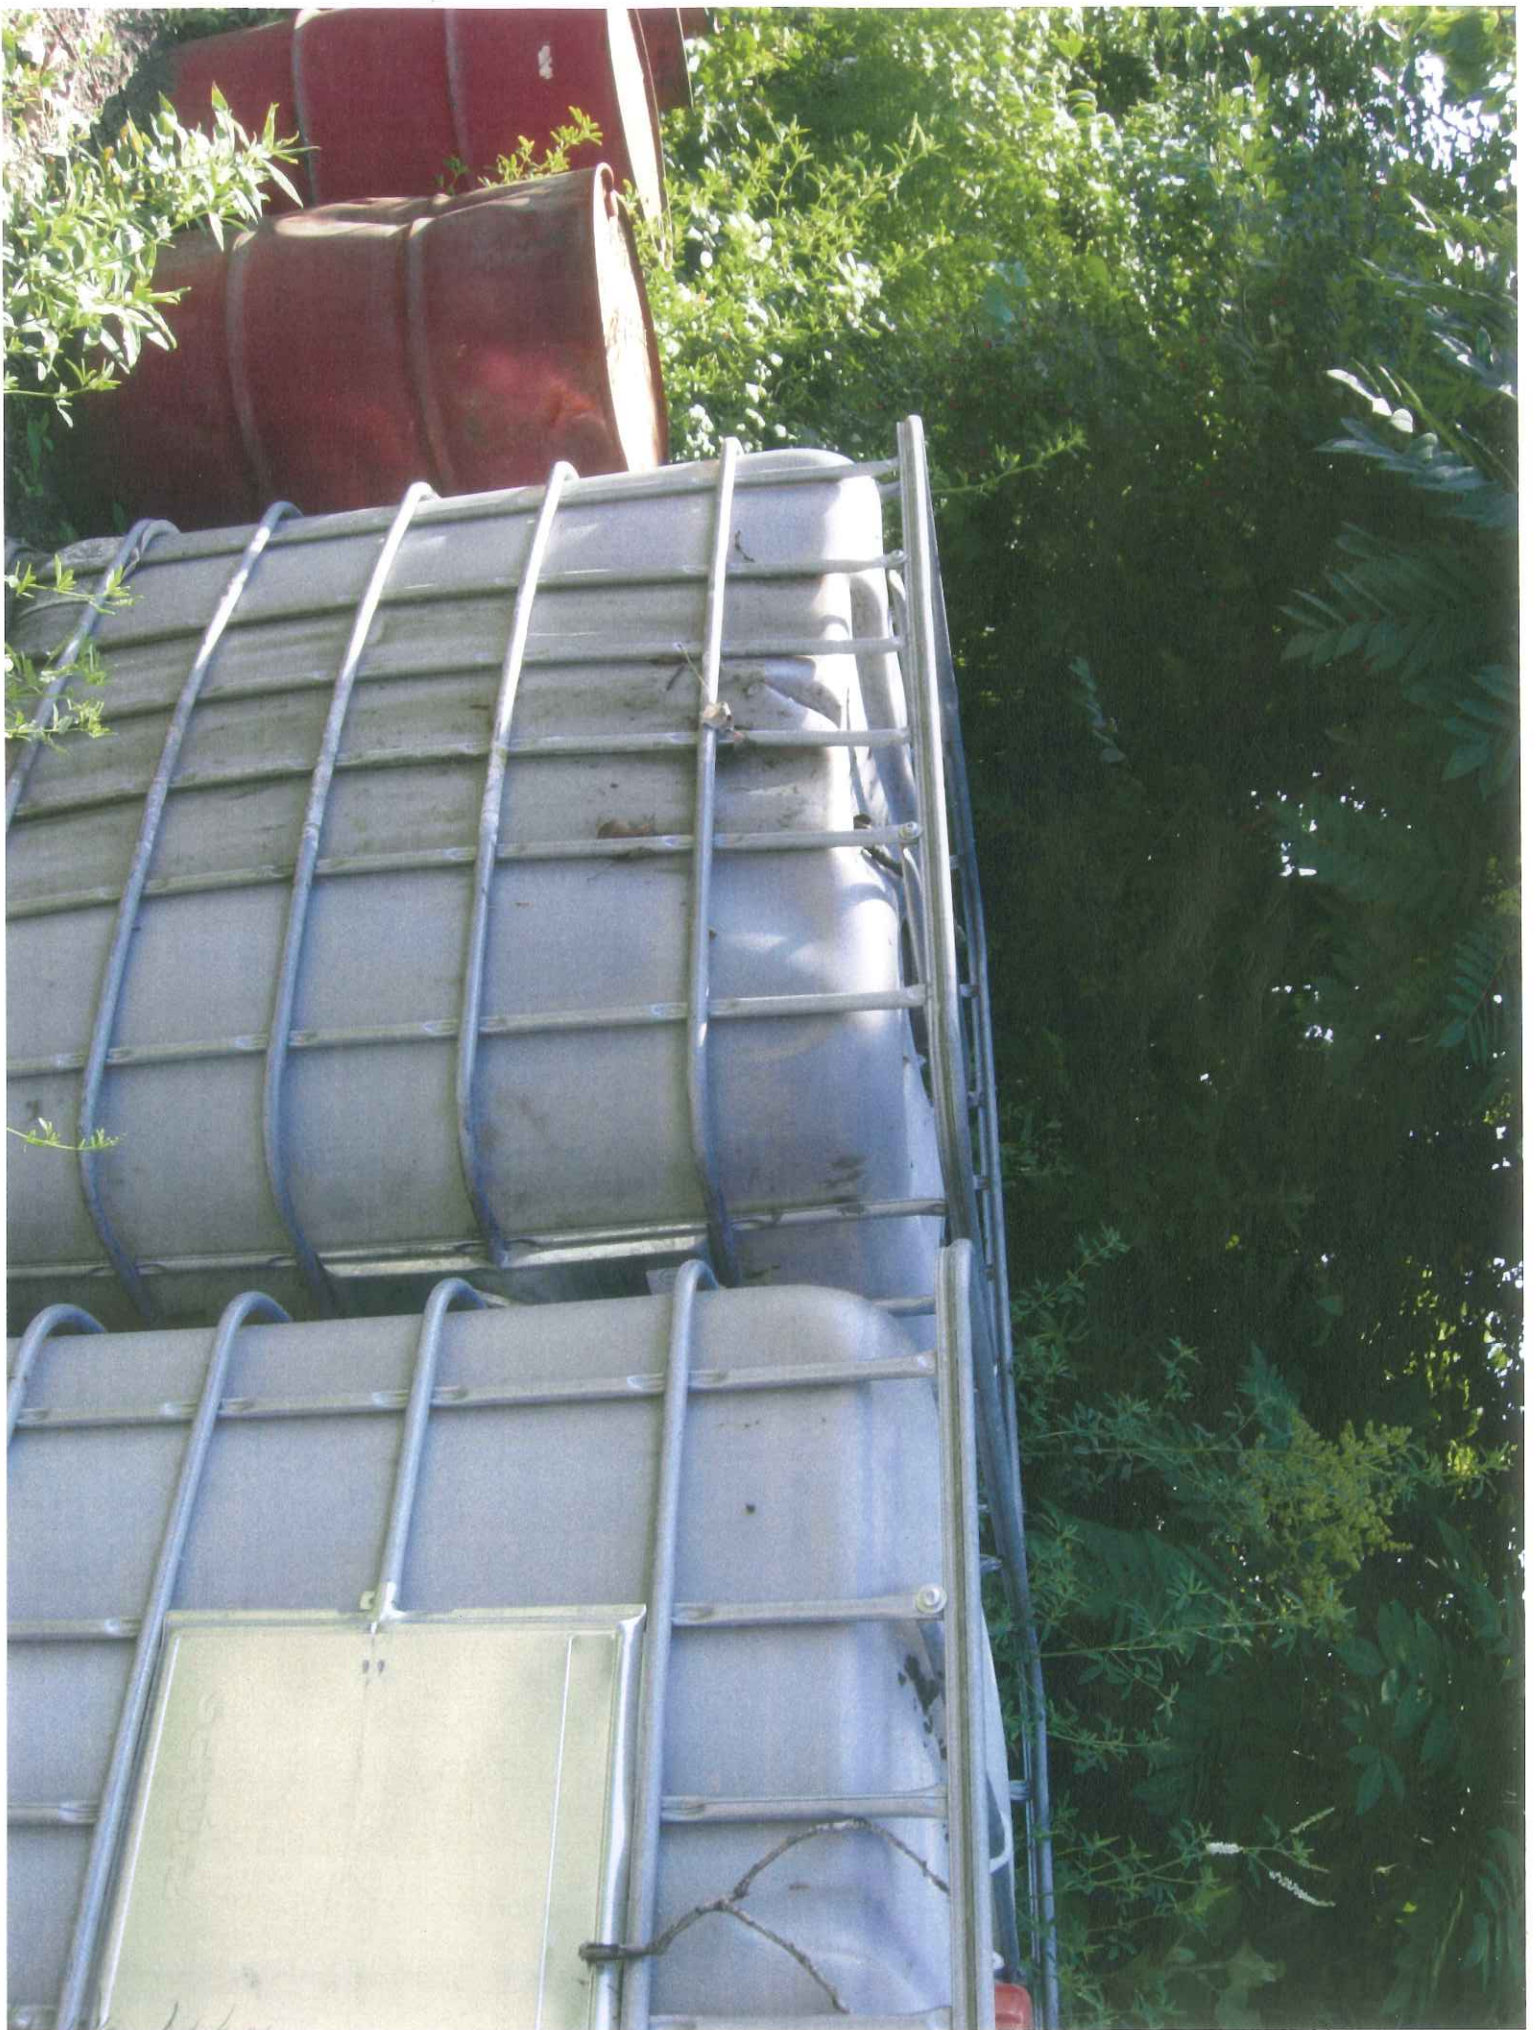
Canton Drop Forge Photo 12, by Mike Beedle ,2011/07/01 07:40:59

| Photo | Description |
|---|--|
| 12 | Two Totes. South side of Pond 2. Totes are ~ 275-gallon and were mostly full. Three full totes in the area, see Photograph 11 for the third tote. |

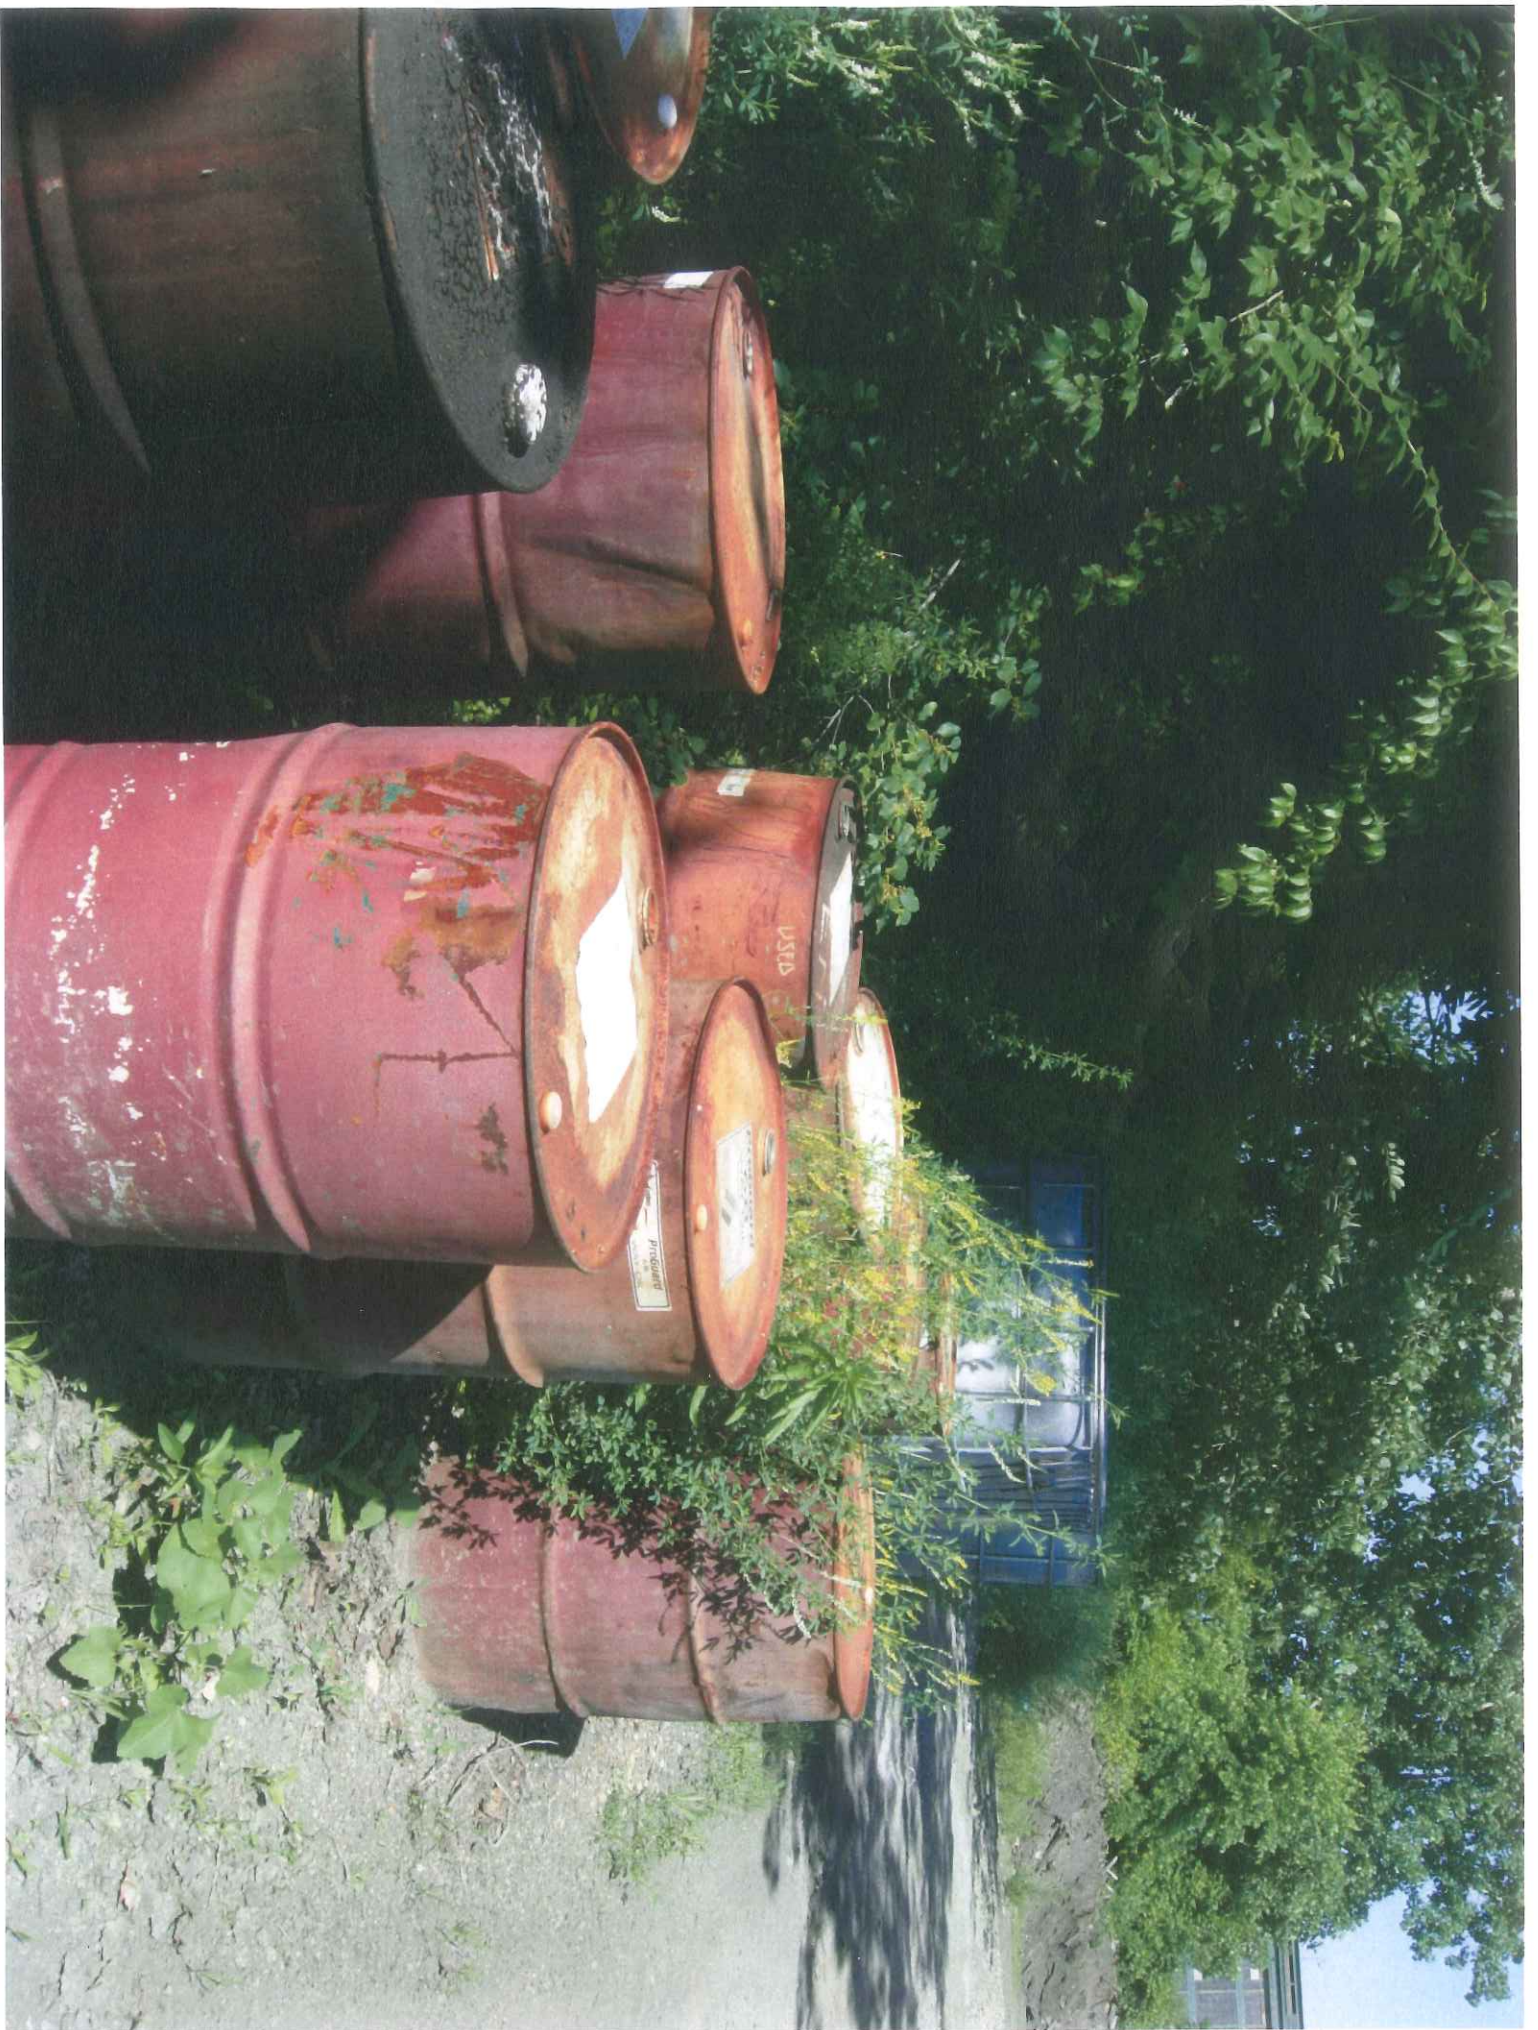
Canton Drop Forge Photo 13, by Mike Beedle ,2011/07/01 07:41:58

| Photo | Description |
|---|--|
| 13 | Ten 55-gallon red drums. South side of Pond 2. At least one of the drums had the word "used" on it. Thought to contain used oil. |

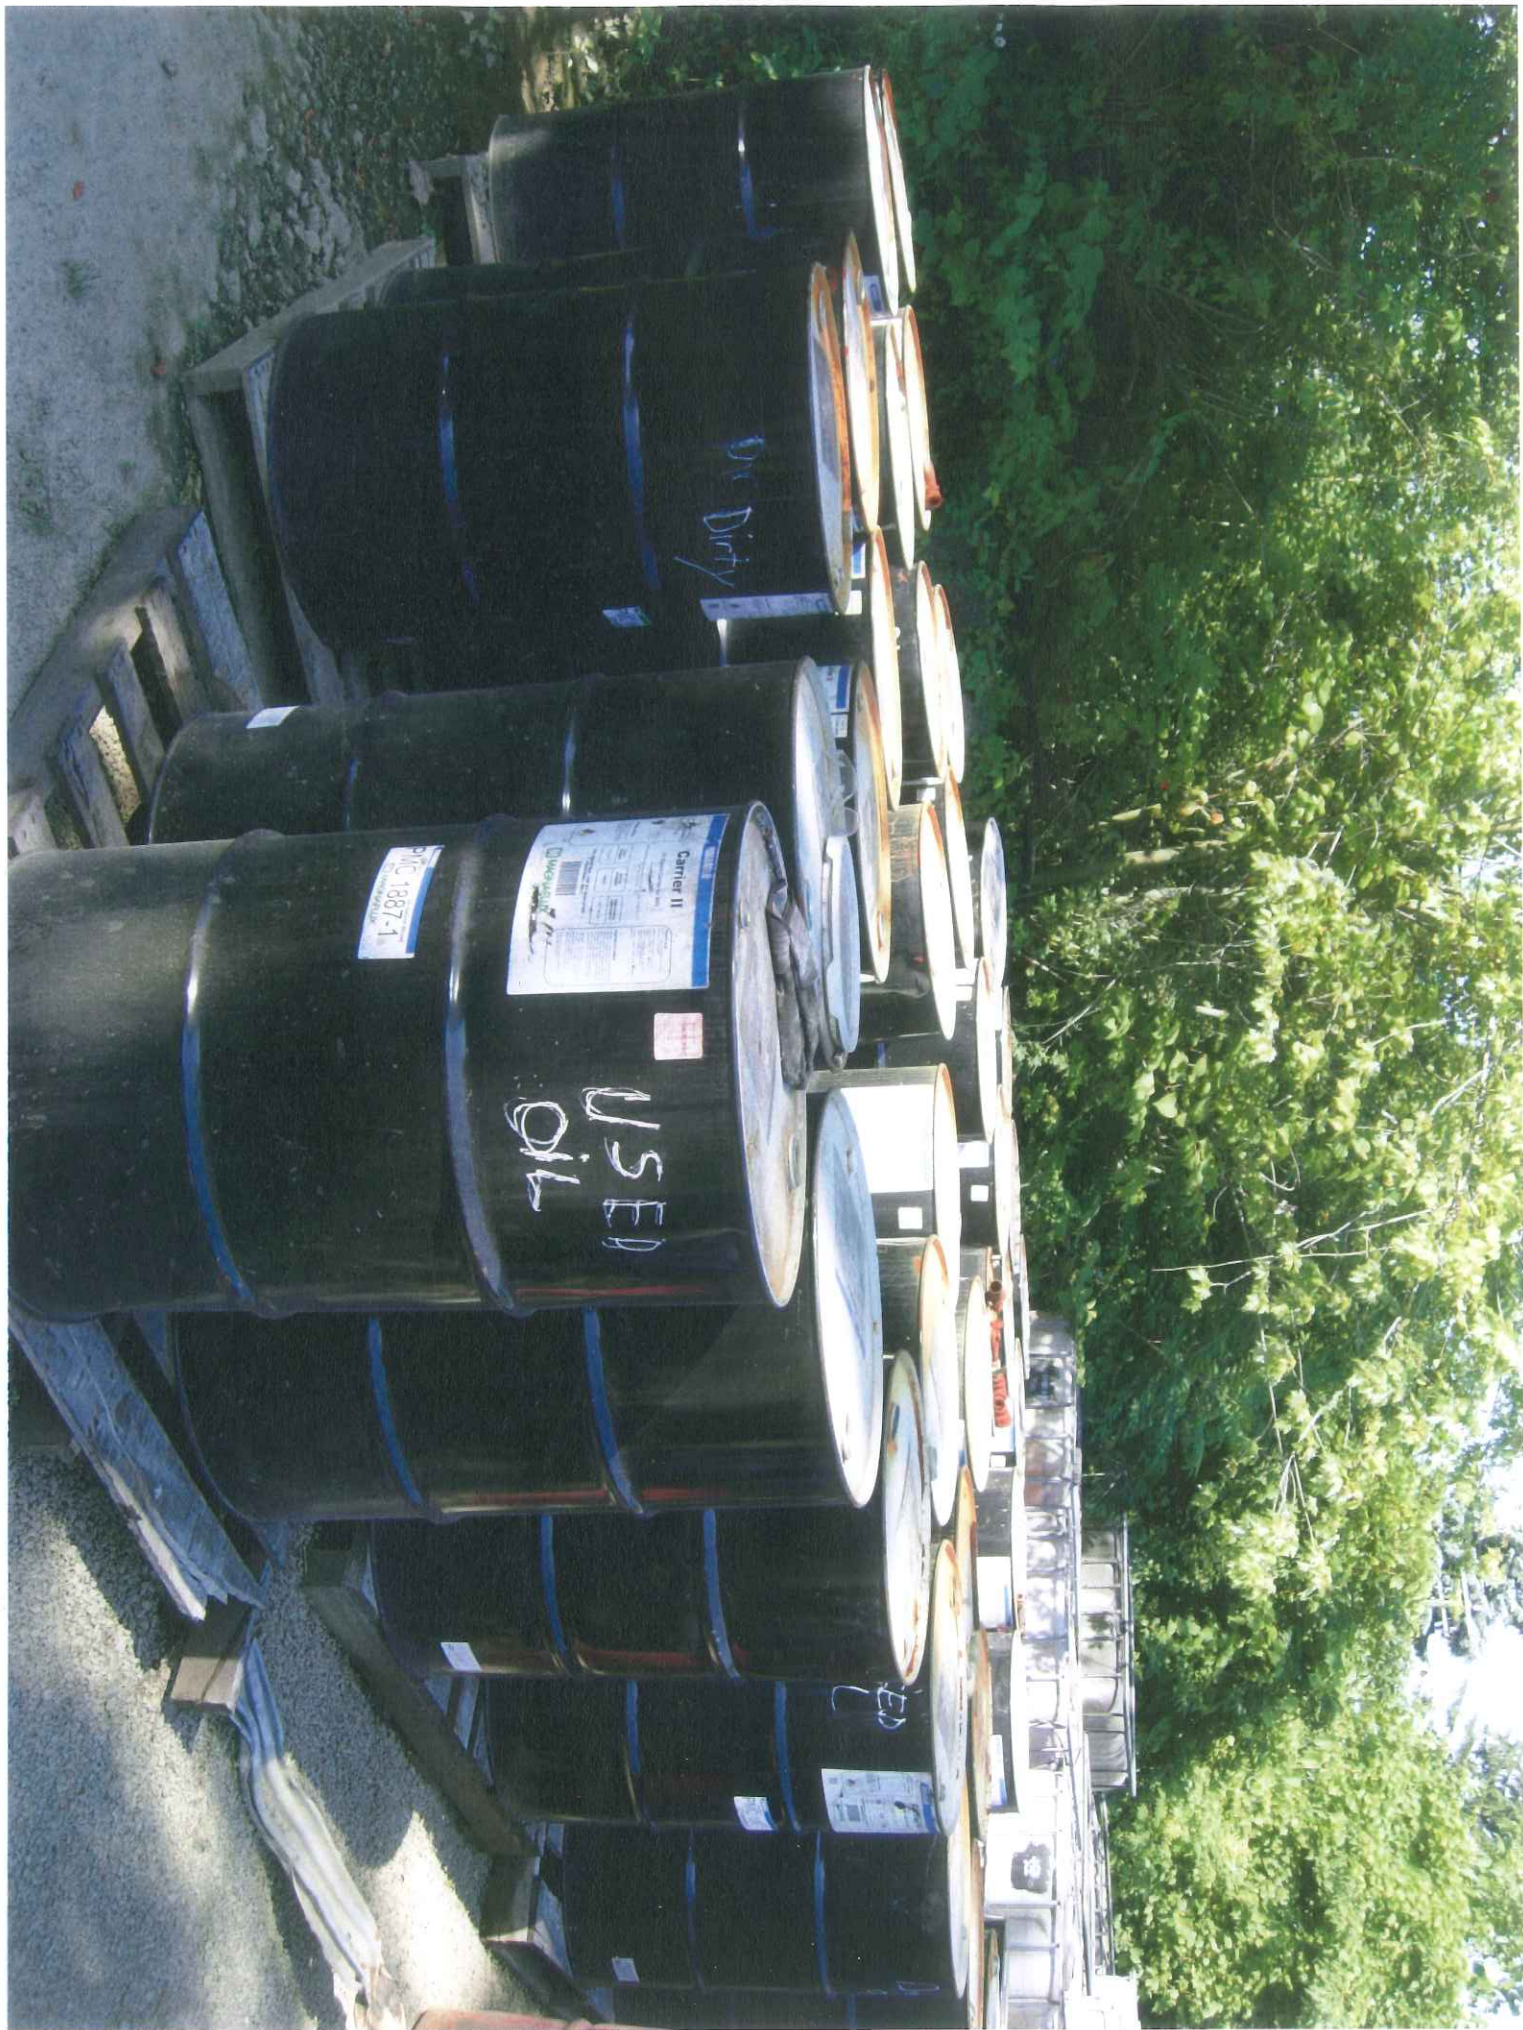
Canton Drop Forge Photo 14, by Mike Beedle ,2011/07/01 07:42:54

Continuing to the southeast corner there were approximately 37 55-gallon black drums (photographs 14-16). The drums for the most part contained liquid when I attempted to move them but a few seemed to have only a small amount of fluid in them. Approximately eight drums were marked "Dirty Oil" and two were marked "Used Oil". Photograph 16 is of animal tracks (raccoon) near the black drums.

| Photo | Description |
|---|--|
| 14 | 37 55-gallon black drums. Southeast side of Pond 2. Eight drums labeled dirty. Two drums labeled used oil. Some seemed full others while others had various volumes of liquid. |
